## **BACHELOR THESIS – ME 141502**

### **ROOT CAUSE ANALYSIS OF KMP RAFELIA 2 ACCIDENT**

Gishela Rahayu Suciati  
NRP. 4213 101 006

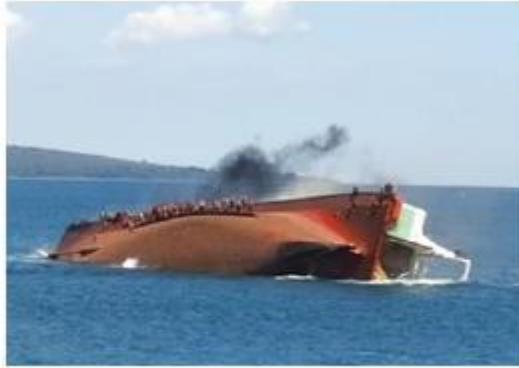
**Figure 1.2 KMP Rafelia 2 Sinking**

In figure 1.2 shows the sinking of KMP Rafelia 2. This accident happened by many factors. This research will analyze root causes of water ingress into car deck that leads to decrease stability and sinking of the ship. The method used in this study is Apollo root cause method, this method is an iterative interrogative technique used to explore the cause-and-effect relationships underlying a particular problem. It is recommended for event/incident-based items of complex and higher significance. Apollo Root Cause Analysis method utilizes a process called RealityCharting which encompasses all known causes as well as their relationships with each other [1].RealityCharting is becoming the standard for all event analysis because it is the only process that understands and follows the cause-and-effect principles, thus it is the only process that allows all stakeholders to create a clear and common reality to promote effective solutions every time[2].

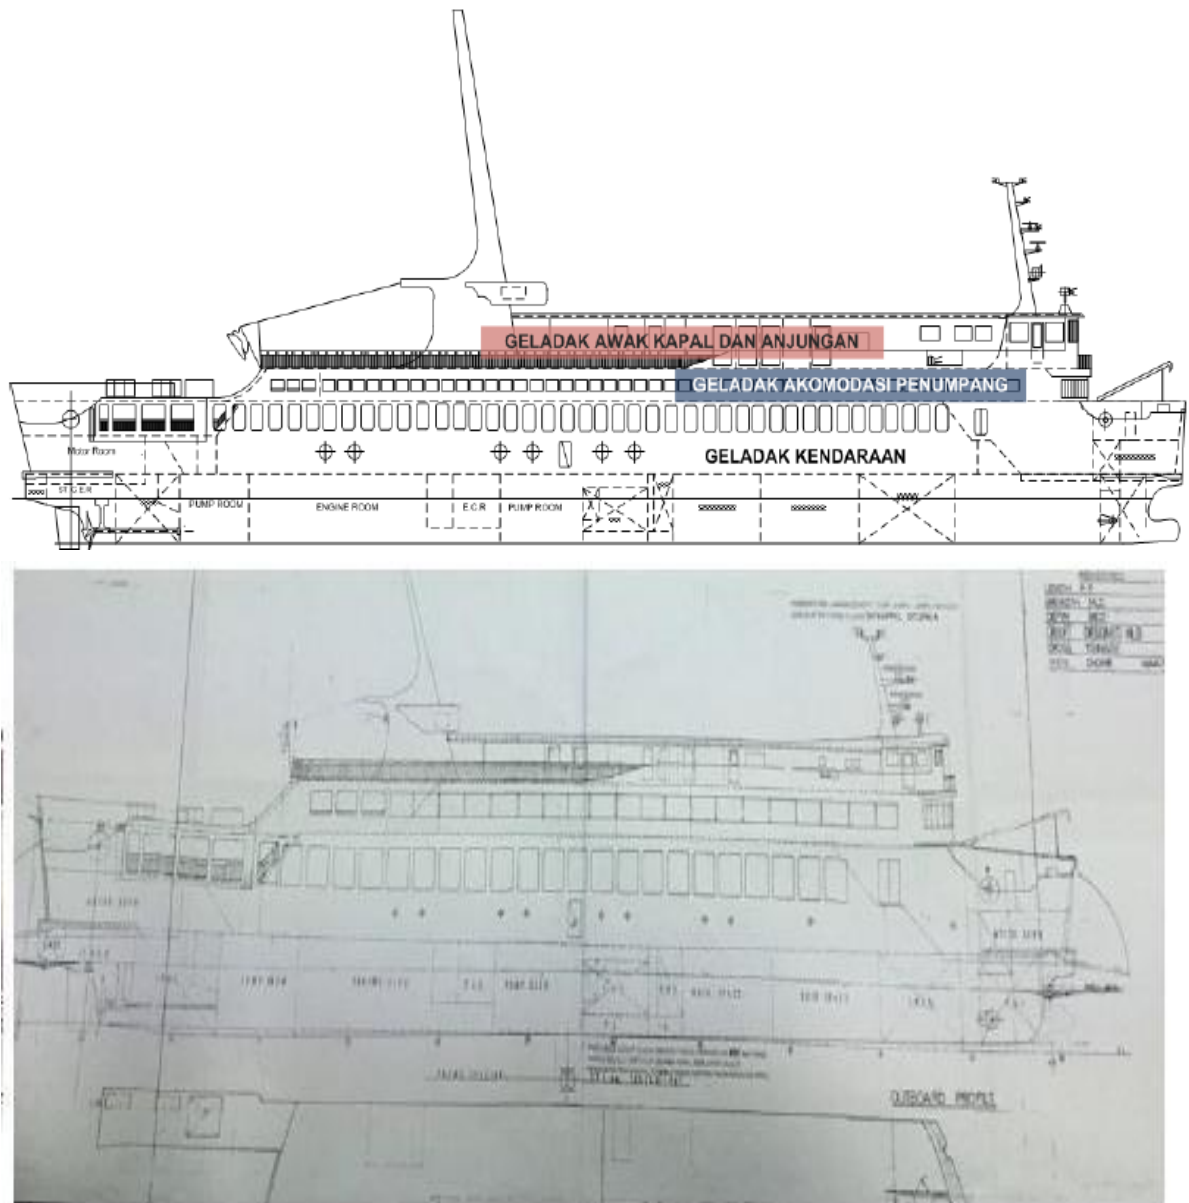
**Figure 4.1 General Arrangement of KMP Rafelia 2[12]**

Figure 4.1 shows the General Arrangement of KMP Rafelia 2. The above figure is general arrangement of KMP Rafelia 2 which was different from the actual condition. The below one is design of general arrangement made at 2012 based on actual condition. The difference between those two designs shows that KMP Rafelia 2 has added the bulbous bow from its original design.

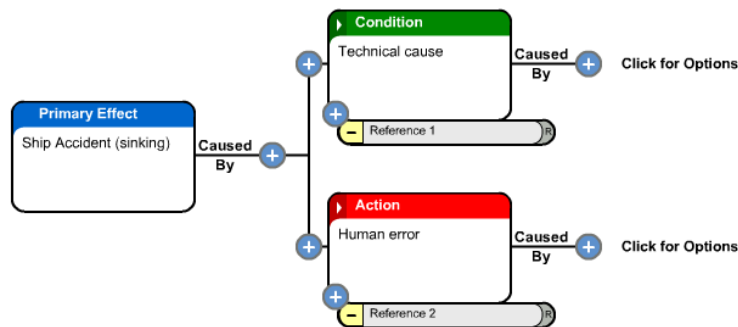
**Figure 4.2 Factors that causing KMP Rafelia 2 sinking**

In working on root cause analysis using RealityCharting which encompasses all known causes as well as their relationships with each other, each event should be determined by action and condition. Ship accident, as the top event, caused by many factors. The factors of this accident are technical cause and human error. Human error is the major cause in most of maritime accident. Therefore, technical cause is the condition and human error is an action. As seen on Figure 4.2

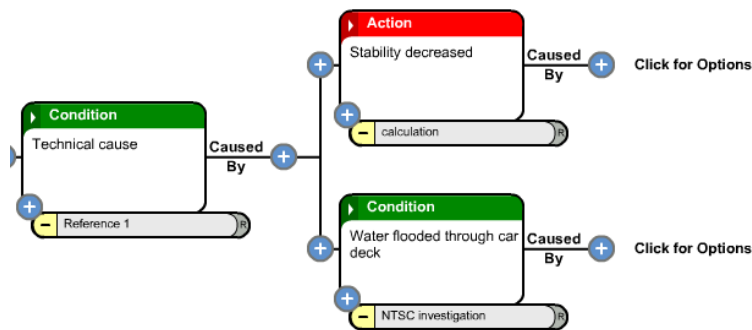
**Figure 4.3 Technical factors**

Furthermore, determine the technical cause and human error. First, define the technical cause of this accident. In KMP Rafelia 2 accident, ship was sinking caused by decrease of ship stability and water that flooded the car deck as seen on figure 4.3 below.

Reasons of decreasing stability are ship stability in departure condition were not in good condition, overload and cargo shifting. According from data, lines plan and general arrangement as supporting data for stability booklet, evidently was

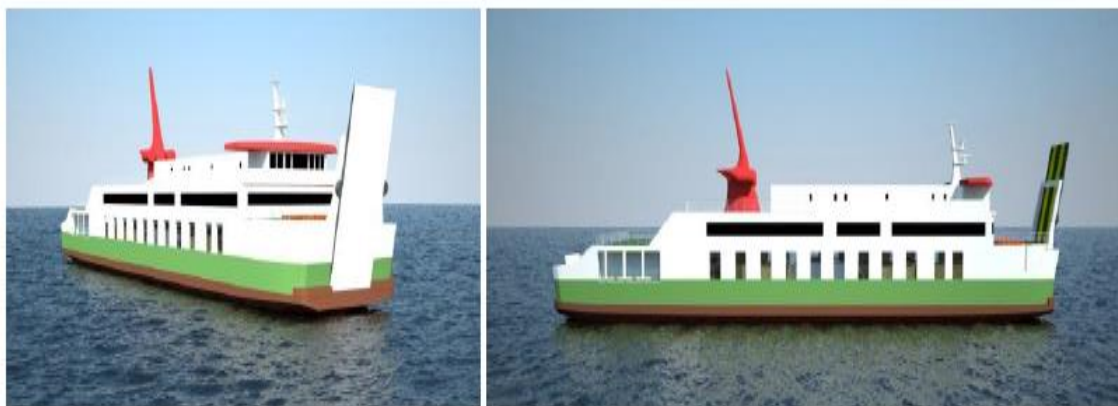
**Figure 4.4 Modification of ramp door[12]**

Another technical factor of this accident is water flooded through car deck. When the chief officer noticed that clinometers showed that the ship heel to starboard, chief officer asked stower to checked the condition in car deck and water already flooded through car deck. The reasons of flooded are ramp door was not closed properly. In ABS part 3 chapter 2 section 9.5 rules for building and classing steel vessel 90 M and above mentioned that doors or ramps may be approved on condition that the shipboard personnel close them before the voyage commences and kept closed during navigation. But, in this case, ramp door was not closed properly because the length of it has been modified from 8 meters to 13 meters. The modification of ramp door is to complied the requirement to be operated as ferry from Ketapang to Gilimanuk. Owner does not report the modification of ramp door to classification.

The modification of ramp door, as seen on figure 4.4, also causing blocking navigation because it longer than it design. In ABS part 3 chapter 6 section 1 about visibility mentioned that the view of sea surface from conning position not to be obscured by more than  $2L_{OA}$  or 500 m. By modifying the ramp door, the view of sea surface from conning position will be disturbed and blocking the navigation. Figure 4.4 shows the modified of ramp door if it close properly.

The condition of ramp door that was not closed properly, water that could not be discharged quickly also causing the flood in car deck. Even scupper are design to discharge water as many as possible, but when water starts flooding in car deck, scupper could not discharge the water quickly. Water that flooded in car deck makes KMP Rafelia 2 lost its stability and heel to starboard.

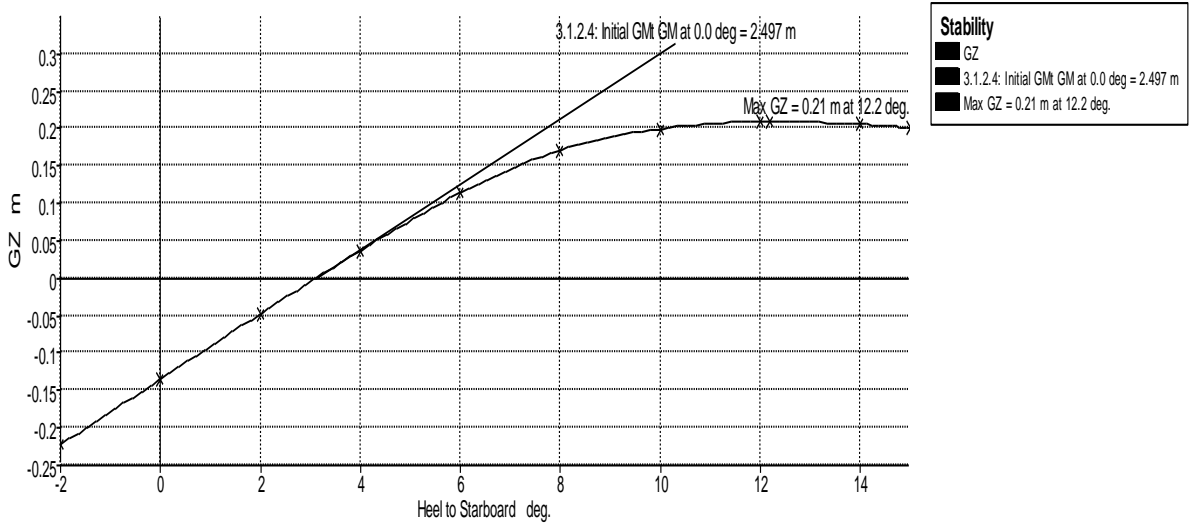
**Figure 4.5 GZ Curve**

Figure 4.7 shows the GZ curve of initial heeling at 5 degree. The ship heeling to starboard. Based on calculation, maximum righting arm is 0.21 m at an angle of heel 12.2 degree. The area under righting lever curve in this condition is less than 0.055 m radian at less than 30 degree. According to criteria based on IMO Res. A.749 (18), the maximum righting arm should occur at an angle of heel not less than 25 degree and area under righting lever (GZ) shall not less than 0.055 m radian at 30 degree. This condition means that stability of this ships does not comply with IMO requirement.

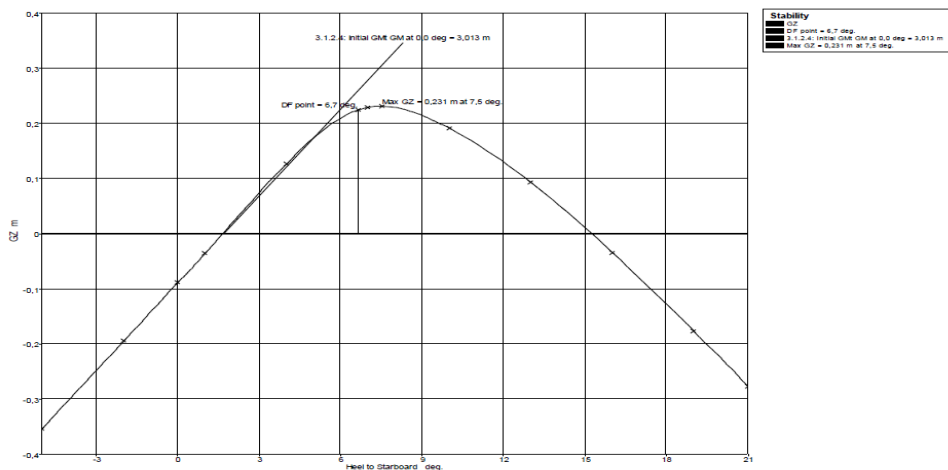
**Figure 4.6 GZ Curve at departure condition[12]**

This calculation will be compared with the stability data from NTSC report. Figure 4.8 shows the stability condition of KMP Rafelia 2 at departure condition from the report. In this condition, KMP Rafelia already inclined at angle of heel 1.5 degree.

Figure above informed that the maximum righting arm at departure condition is 0.231 m with the righting moment at 7.5 degree. According to the requirement, IMO A.749 (18), GM condition is in acceptable range, but the righting arm condition was unacceptable. This condition can cause the risk of its stability.

On the other hand, the risk could be increasing because of sea condition. Displacement of KMP Rafelia 2 is 1478 tons while from the main particular, displacement of this ship is 1219 tons. It shows that KMP Rafelia 2 is overload about 259 tons. This condition could be decreasing the stability.

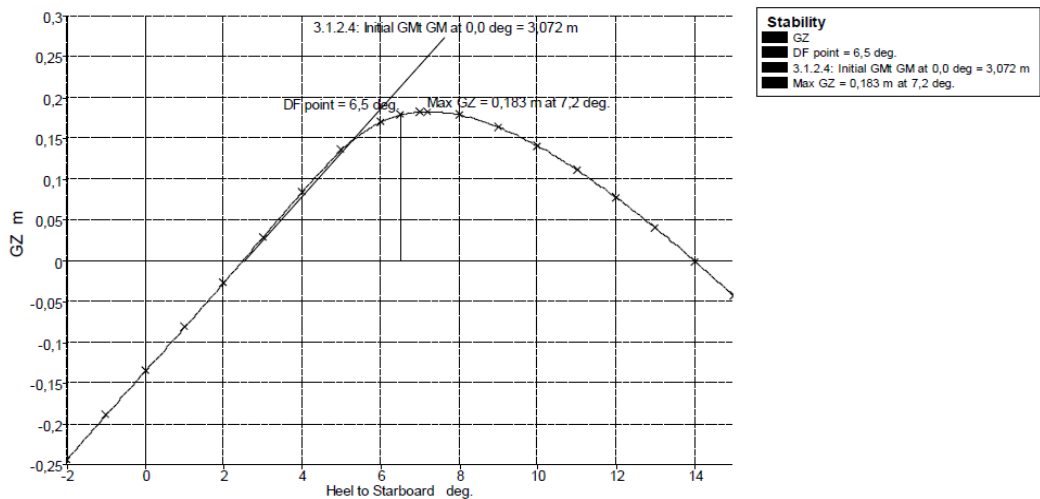
**Figure 4.7 GZ Curve at initial heeling 5 degree[12]**

Figure 4.9 shows the condition of KMP Rafelia 2 at initial heeling 5 degree. It calculated by NTSC. Maximum GZ in this curve is 0.183 m while the righting moment is at 7.2 degree. The initial GM at 0.0 degree is 3.072 m. Comparing with the previous calculation at the same condition, we will see difference amount of maximum righting arm and different number of righting moment. But, both of calculation, none of them are comply with the requirement.
