PRIORITAS PENANGANAN KERUSAKAN JALAN DI JALAN PROVINSI DI DAERAH SURABAYA SELATAN DITINJAU DARI TINGKAT KERUSAKAN JALAN DAN SEGI EKONOMI

AZIZAH SAGITA AMANI
NRP. 03111540000075

DEPARTEMEN TEKNIK SIPIL
Fakultas Teknik Sipil, Lingkungan, Dan Kebumian
Institut Teknologi Sepuluh Nopember
Surabaya
2019

**ROAD DAMAGE TREATMENT PRIORITY ON
PROVINCIAL ROADS IN SOUTH SURABAYA AREA
BASED ON THE LLEVEL OF ROAD DAMAGE AND
ECONOMIC ASPECTS**

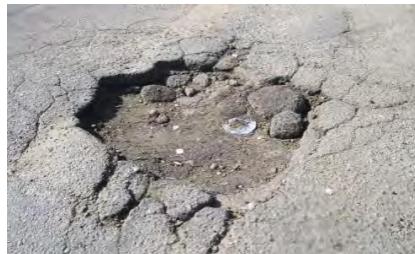
Gambar 2.1 *Potholes*

umumnya disebabkan kelemahan perkerasan akibat terlalu sedikitnya aspal dan drainase yang buruk. Lubang yang diobservasi hanya lubang yang mempunyai luas lebih dari 1 foot persegi ($+/- 0,090 \text{ m}^2$).

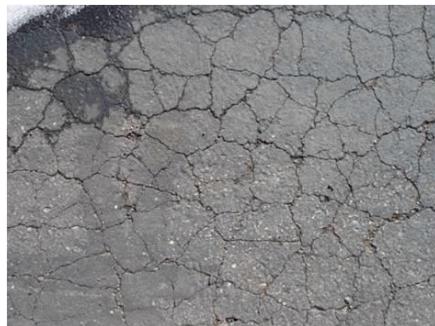
Gambar 2.2 *Alligator Cracking*

Menurut Sukirman (1999), alligator cracking/retak kulit buaya ditandai dengan celah yang lebih besar atau sama dengan 3mm yang, Keretakan pada jalan yang saling berhubungan membentuk kotak-kotak kecil yang mirip dengan kulit buaya.

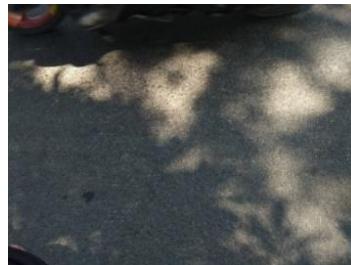
Gambar 2.3 *Ravelling*

Pengelupasan partikel perkerasan dari permukaan jalan. Mula-mula partikel-partikel agregat halus lepas dan akhirnya permukaan menjadi kasar sekali. Penyebab utamanya kurangnya pemasatan, agregat yang digunakan kurang bersih, dan terlalu sedikitnya aspal campuran.

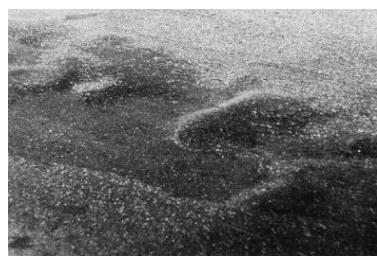
Gambar 2.4 *Profile Distortion*

1. Sungkur adalah deformasi plastis yang terjadi setempat misalnya ditempat kendaraan pada saat berhenti, kelandaian curam, dan tikungan tajam.
2. Keriting adalah alur yang melintang jalan.
3. Ambles adalah penurunan permukaan jalan yang terjadi setempat dengan atau tanpa retak dan ditandai dengan genangan.
4. Jembul adalah penonjolan permukaan jalan yang terjadi setempat dengan atau tanpa retak.

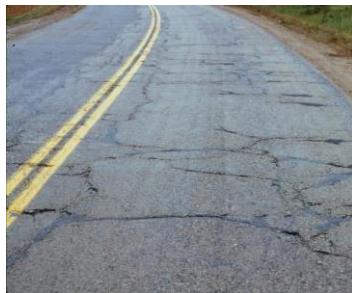
Gambar 2.5 *Block Cracking*

Retak blok ini berbentuk blok-blok besar yang saling bersambungan, dengan ukuran sisi balok 0,2 meter sampai 3 meter, dan dapat membentuk sudut atau pojok yang tajam.

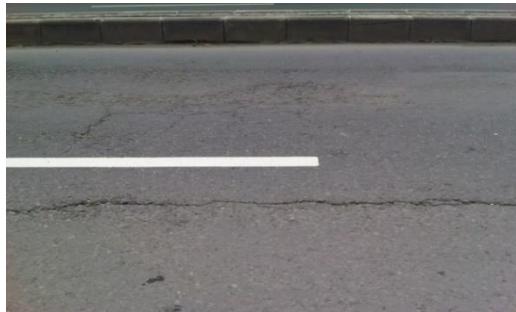
Gambar 2.6 *Longitudinal Cracking*

Retak berbentuk memanjang pada perkerasan jalan dapat terjadi dalam bentuk tunggal atau berderet yang sejajar, dan kadang-kadang sedikit bercabang. Retak memanjang dapat terjadi oleh labilnya lapisan pendukung dari struktur perkerasan.

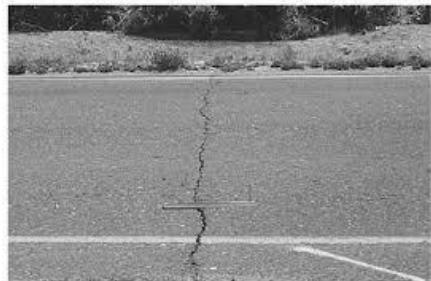
Gambar 2.7 *Transverse Cracking*

Retak melintang merupakan retakan tunggal (tidak bersambungan satu sama lain) yang melintang perkerasan. Perkerasan, retak ketika temperature atau lalu lintas menimbulkan tegangan dan regangan yang melampaui kuat Tarik atau kelelahan campuran aspal padat. Retak melintang ini biasanya berjarak yang mendekati sama.

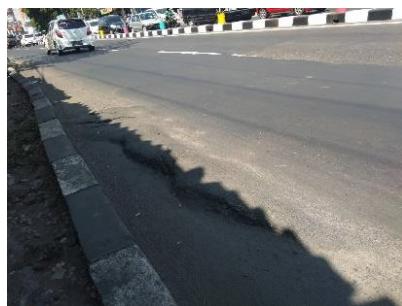
Gambar 2.8 *Rutting (Alur)*

Berupa alur memanjang umumnya terjadi pada jejak roda. Hal ini disebabkan terjadinya penurunan atau pergerakan ke atas pada lapisan bawah perkasan akibat beban lalu lintas atau pergerakan lapisan aspal sendiri.

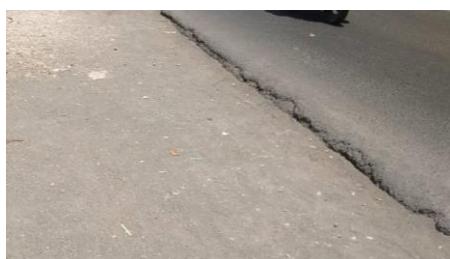
Gambar 2.9 *Edge Deterioration*

Retak yang memisahkan perkerasan bahu jalan.

Penyebab umum dari keretakan ini karena keadaan tanah di bawah bahu jalan mengalami perubahan kadar air yang disebabkan kondisi drainase yang buruk.

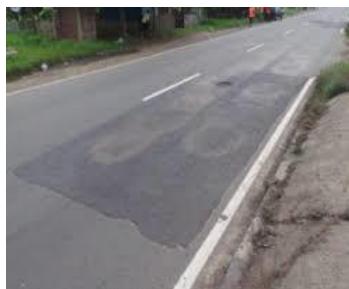
Gambar 2.10 *Bituminous Patching*

Adalah penutupan bagian perkerasan yang mengalami perbaikan. Kerusakan tambalan dapat diikuti/tidak diikuti oleh hilangnya kenyamanan kendaraan atau rusaknya struktur perkerasan.
