FIRE CAUSE ANALYSIS ON WOODEN SHIP KM. IZHAR

Regian Ganang Alfarizi

DOUBLE DEGREE PROGRAM

DEPARTMENT OF MARINE ENGINEERING

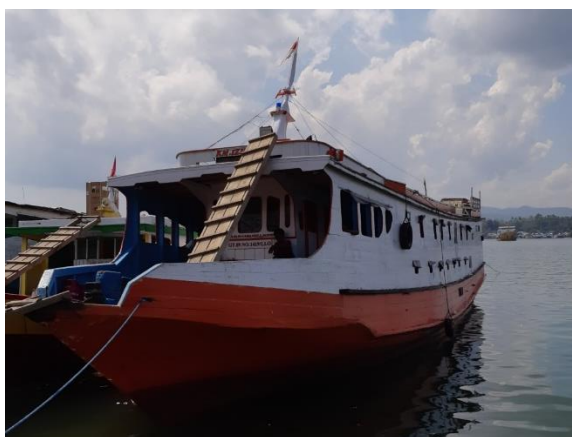
Figure 4.1. KM. Izhar

Around 23.00 WITA, one of the passenger found out that there was smoke came out from the engine room's door. Oilman who heard the passenger then immediately went to engine room and the smoke already gotten dark. From the oilman view, the fire source was in the secondary engine. The oilman with crew then pick up the water from the barrel which locate in the ship's stern then flush the water into engine room. The smoke that got thicker prevents the oilman and crew to enter the engine room. Passenger in accommodation room immediately run to ship's bow to avoid fire. The captain then turn off the engine and searching any safe place to ground the ship. But since the rudder became uncontrollable, the ship just float off. The fire got bigger, passenger started to jump to the sea. Life

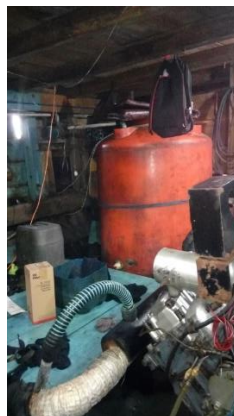
Figure 4.3. KM Izhar Engine Room

From the investigation, can be found also the fact that KM Izhar were using marinized diesel engine. From KM. Izhar engine room photo documentation as show in figure 4.3., there are some parts that was modified such as piping and fuel tank. For piping, KM Izhar use PVC pipe and flexible rubber tube/hose. For its fuel tank, KM Izhar use plastic reservoir that usually used in households.

Based on NCVS Chapter II section 23.1 for non-portable fuel tanks, the construction is should be made of carbon steel, stainless steel, copper, marine-grade aluminum alloy or FRP. In 1990 American Boat and Yacht Council make standard for fuel tank corrosion resistance requirements as can be seen on table 4.4.
