## **BACHELOR THESIS – ME 141502**

### **ROOT CAUSE ANALYSIS OF KMP RAFELIA 2 ACCIDENT**

Gishela Rahayu Suciati  
NRP. 4213 101 006

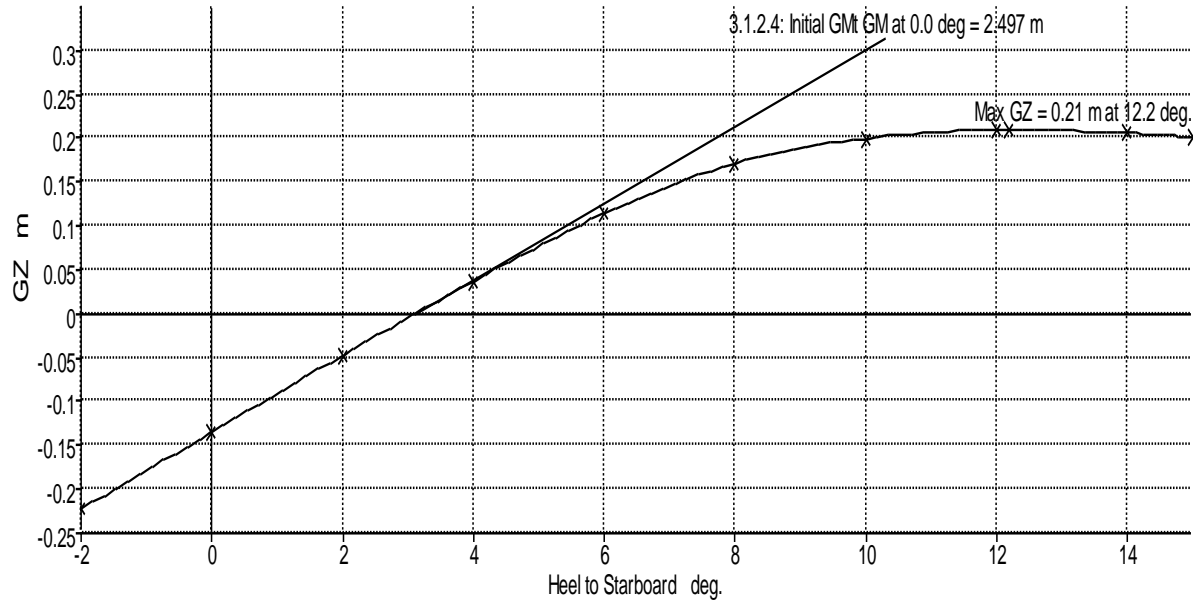
Heel to Starboard deg	-2.0	0.0	2.0	4.0	6.0	8.0	10.0	12.0	14.0	15.0
GZ m	-0.222	-0.135	-0.048	0.037	0.114	0.171	0.200	0.210	0.206	0.201
Area under GZ curve from zero heel m.rad	0.0060	-0.0008	0.0031	-0.00327	-0.0006	0.0042	0.0106	0.0176	0.0247	0.0282
Displacement t	1484	1484	1484	1484	1484	1484	1484	1484	1484	1484
Draft at FP m	3.511	3.519	3.511	3.490	3.457	3.434	3.431	3.440	3.457	3.467
Draft at AP m	3.020	3.025	3.020	3.002	2.977	2.944	2.905	2.870	2.836	2.821
WL Length m	65.259	65.277	65.259	65.410	65.561	66.146	66.147	66.197	66.198	66.198
Beam max extents on WL m	13.053	13.018	13.054	12.864	12.914	12.923	12.978	13.057	13.155	13.212
Wetted Area m <sup>2</sup>	988.421	990.657	988.439	979.641	983.676	1036.737	1084.035	1131.288	1176.594	1196.786
Waterpl. Area m <sup>2</sup>	711.481	713.766	711.496	701.178	688.395	641.104	597.759	560.849	529.331	516.862
Prismatic coeff. (Cp)	0.613	0.612	0.613	0.612	0.611	0.608	0.612	0.616	0.622	0.625

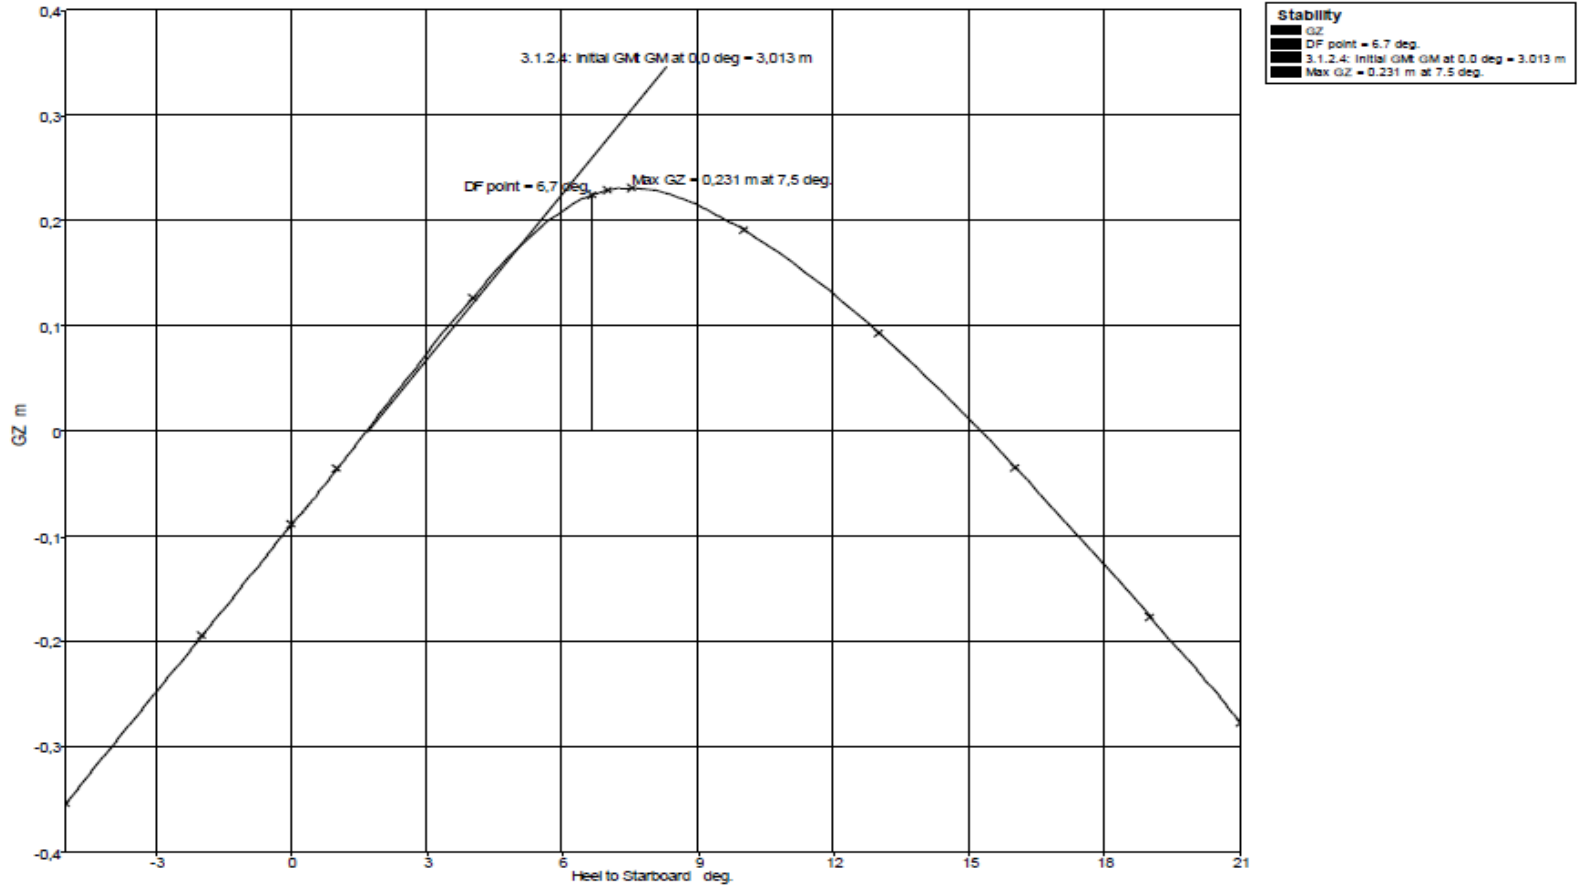
Heel to Starboard deg	-5,0	-2,0	0,0	1,0	4,0	7,0	10,0	13,0	16,0	19,0	21,0
GZ m	-0,354	-0,194	-0,088	-0,036	0,127	0,229	0,192	0,093	-0,034	-0,176	-0,277
Area under GZ curve from zero heel m.deg	1,1047	0,2823	-0,0179	-0,0626	0,0789	0,6442	1,3018	1,7381	1,8333	1,5209	1,0684
Displacement t	1474	1474	1474	1474	1474	1474	1474	1474	1474	1474	1474
Draft at FP m	3,336	3,379	3,387	3,385	3,353	3,312	3,317	3,358	3,425	3,514	3,583
Draft at AP m	3,255	3,293	3,301	3,299	3,273	3,227	3,220	3,237	3,271	3,320	3,359
WL Length m	65,364	65,240	64,841	64,815	65,345	65,373	65,410	65,468	65,473	65,476	65,477
Beam max extents on WL m	12,550	12,518	12,480	12,489	12,530	10,818	9,293	8,383	7,777	7,351	7,135
Wetted Area m <sup>2</sup>	978,153	987,164	980,853	981,888	985,981	1051,909	1131,387	1179,561	1212,309	1236,370	1249,230
Waterpl. Area m <sup>2</sup>	769,900	784,322	777,763	778,660	782,562	649,761	526,073	450,802	399,624	362,478	342,928

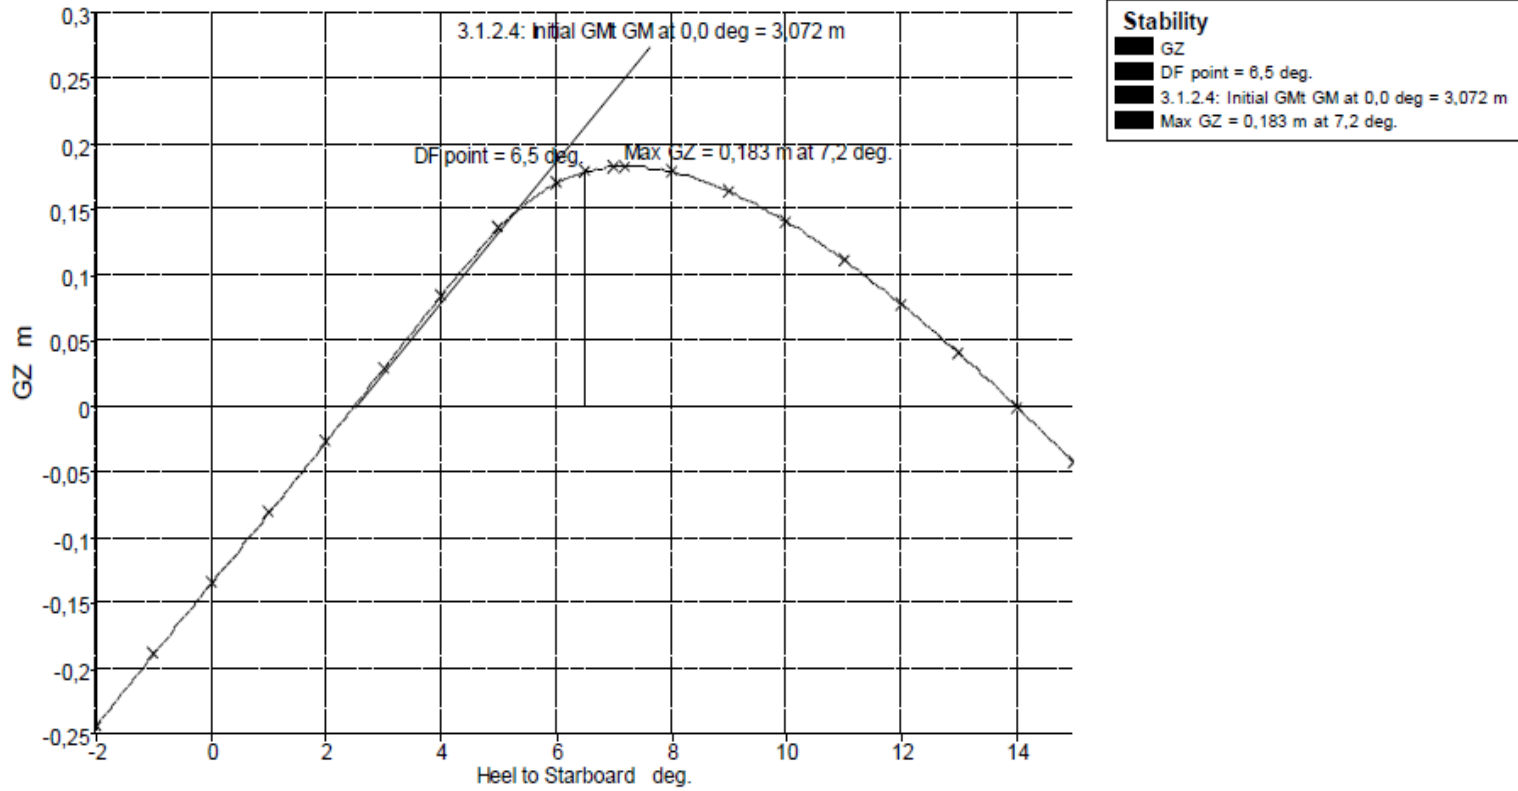
Heel to Starboard deg	-2,0	-1,0	0,0	1,0	2,0	3,0	4,0	5,0	6,0	7,0	8,0	9,0	10,0	11,0	12,0	13,0	14,0	15,0
GZ m	-0,243	-0,189	-0,135	-0,081	-0,027	0,029	0,085	0,136	0,170	0,183	0,179	0,164	0,141	0,112	0,078	0,041	0,000	-0,043
Area under GZ curve from zero heel m.rad	0,0066	0,0028	-0,0004	-0,0019	-0,0028	-0,0028	-0,0018	0,0001	0,0028	0,0060	0,0091	0,0121	0,0148	0,0170	0,0187	0,0197	0,0201	0,0197
Displacement t	1484	1484	1484	1484	1484	1484	1484	1484	1484	1484	1484	1484	1484	1484	1484	1484	1484	1484
Draft at FP m	3,392	3,399	3,401	3,399	3,392	3,380	3,365	3,348	3,335	3,326	3,323	3,327	3,334	3,345	3,360	3,377	3,398	3,421
Draft at AP m	3,305	3,310	3,312	3,310	3,306	3,298	3,285	3,268	3,253	3,244	3,240	3,239	3,241	3,246	3,253	3,262	3,273	3,286
WL Length m	65,259	65,002	65,029	65,003	65,259	65,322	65,351	65,369	65,368	65,377	65,386	65,396	65,417	65,445	65,466	65,468	65,469	65,470
Beam max extents on WL m	12,568	12,541	12,531	12,541	12,569	12,614	12,531	12,504	11,466	10,694	10,086	9,594	9,184	8,838	8,541	8,283	8,058	7,860

Code	Criteria	Value	Units	Actual	Status	Margin %
A.749(18) Ch3 - Design criteria applicable to all ships	3.1.2.3: Angle of maximum GZ				Fail	
	shall not be less than ( $\geq$ )	25,0	deg	7,2	Fail	-71,27
A.749(18) Ch3 - Design criteria applicable to all ships	3.1.2.4: Initial GMt				Pass	
	spec. heel angle	0,0	deg			
	shall not be less than ( $\geq$ )	0,150	m	3,072	Pass	+1948,00
